Your Inspection Report

XXXXXXX XXXXX, MI XXXX

INSPECTION DATE: Friday, January 13, 2017

| SUMM | ARY | | | | | | Report | t No. 1081 | |

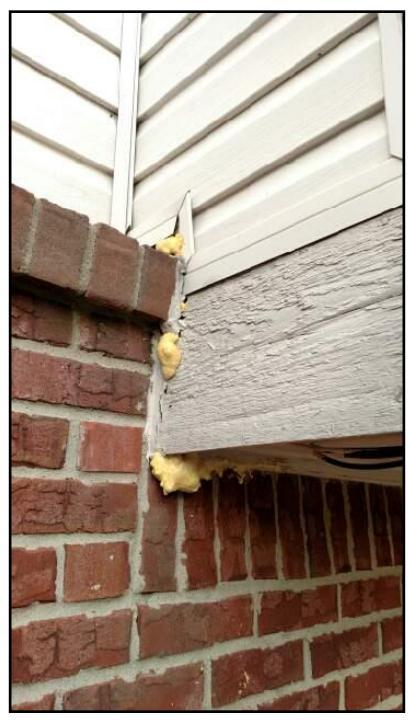
10. Right Side - Repairs

2. Condition: • Foam sealant on the exterior wall showed signs of poor installation. The Inspector recommends that an evaluation and any necessary work be performed by a qualified licensed contractor.

Location: Right Side Exterior

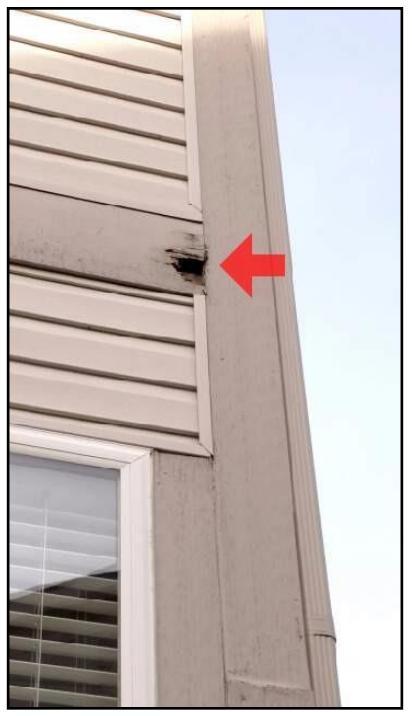
16. Right Side - Rot or insect damage

5. Condition: • Rot

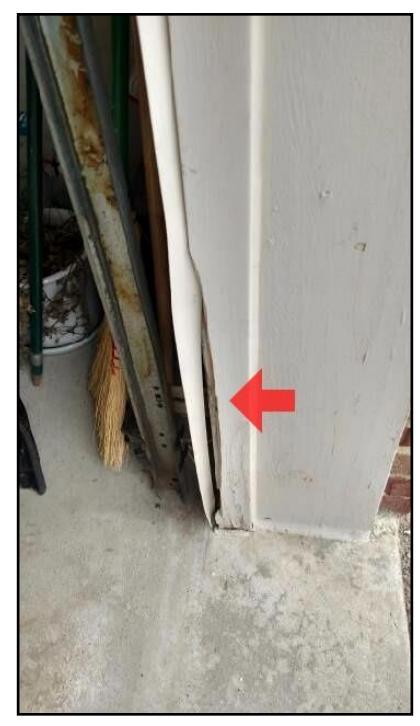
7. Condition: • Damaged weather strip Recommend replacement by a qualified licensed contractor.

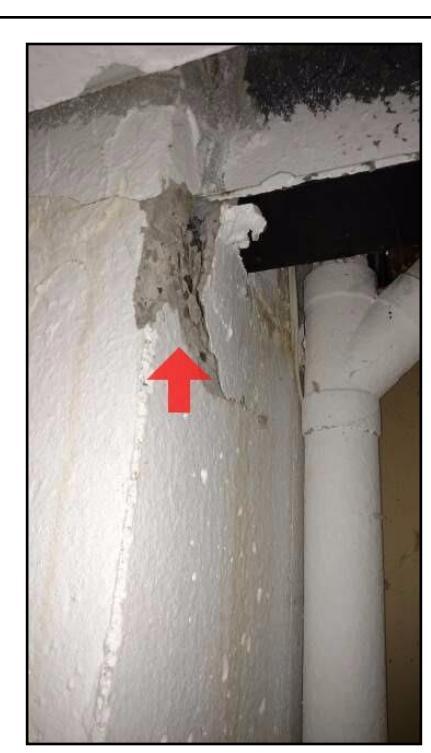
32. Spalling, crumbling or broken material

Condition: • Spalling, crumbling or broken material

Pop-outs were visible in the surfaces of the concrete foundation walls. Pop-outs are shallow, conical sections which break away from the surface of concrete. The cause appeared to be expansion of low quality aggregate used in the concrete mix from which the wall was constructed. Inspector recommends repair by a qualified licensed contractor. **Implication(s)**: Weakened structure | Chance of structural movement **Location**: Basement

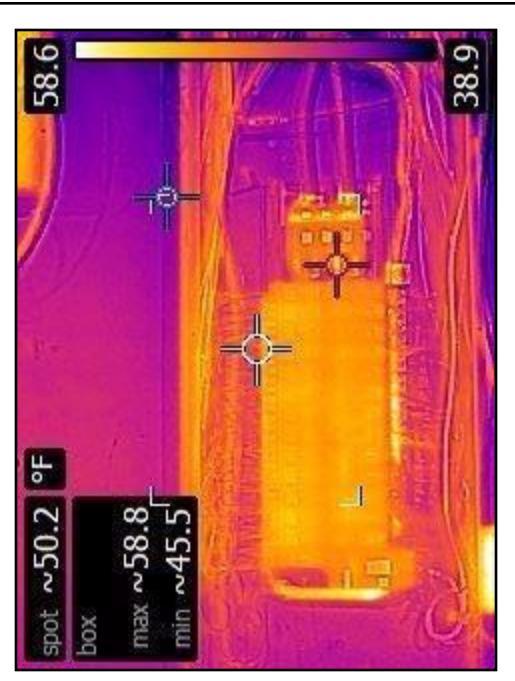
39. Breakers - basement

Condition: • Wrong breaker for panel

Circuit breakers in the service panel were of a brand different from the main panel brand. Because circuit breakers made by different manufacturers vary in design, panel manufacturers typically require that breakers manufactured by their company be used in their panels. Breakers from one manufacturer used in the panel of another manufacturer may result in poor connections which can create a potential fire or shock/electrocution hazard. The Inspector recommends correction by a qualified electrical contractor.

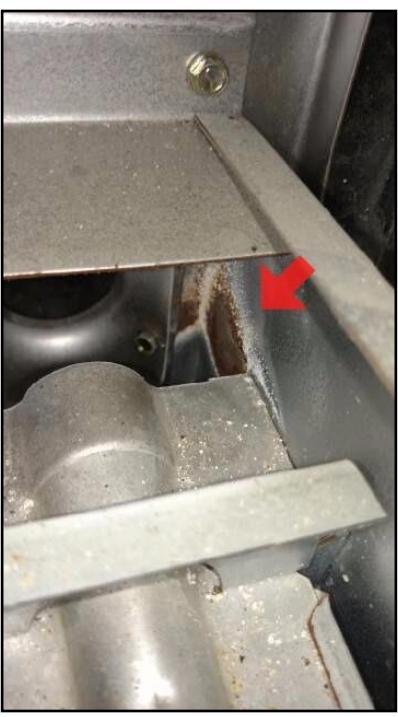
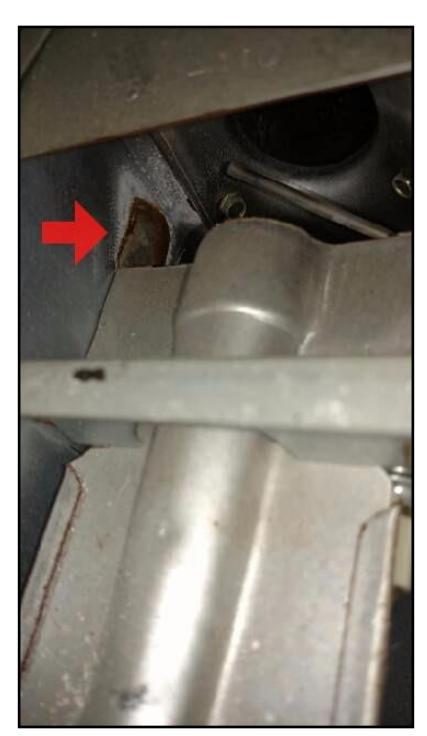
83. Rust

18. Condition: • Rust

Implication(s): Material deterioration | Reduced system life expectancy

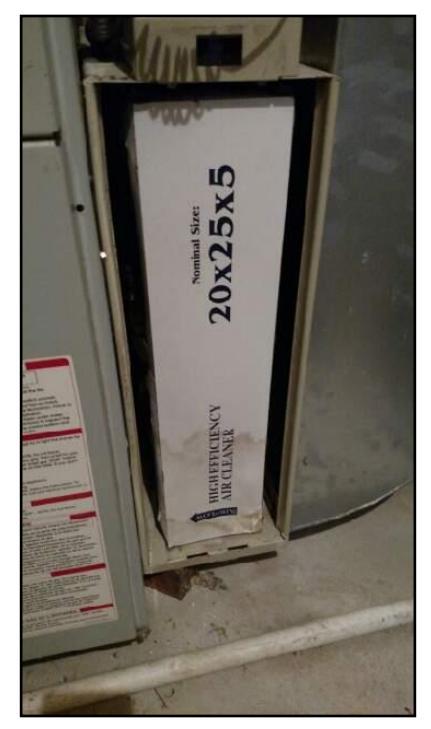
85. Dirty

Condition: • Dirty

The air filter for this furnace was dirty and should be changed. Filters should be checked every three months and replaced when they reach a condition in which accumulation of particles becomes so thick that particles may be blown loose from the filter and into indoor air. Homes in areas with high indoor levels of airborne pollen or dust may need to have air filters checked and changed more frequently. Failure to change the filter when needed may result in the following problems: - Reduced blower life due to dirt build-up on vanes, which increasing operating costs. - Reduced indoor air quality. - Increased resistance resulting in the filter being sucked into the blower. This condition can be a potential fire hazard. - Frost build-up on air-conditioner evaporator coils, resulting in reduced cooling efficiency and possible damage. - Reduced air flow through the home.

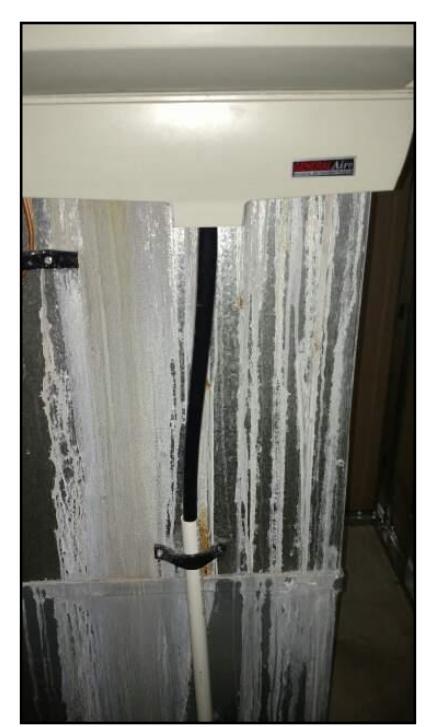
87. Leak

Water stains on the duct work indicate prior leak most likely do to a clogged pad. The Inspector recommends that the humidifier be serviced by a qualified HVAC contractor.

Implication(s): Chance of water damage to contents, finishes and/or structure | Damage to equipment **Location**: Basement

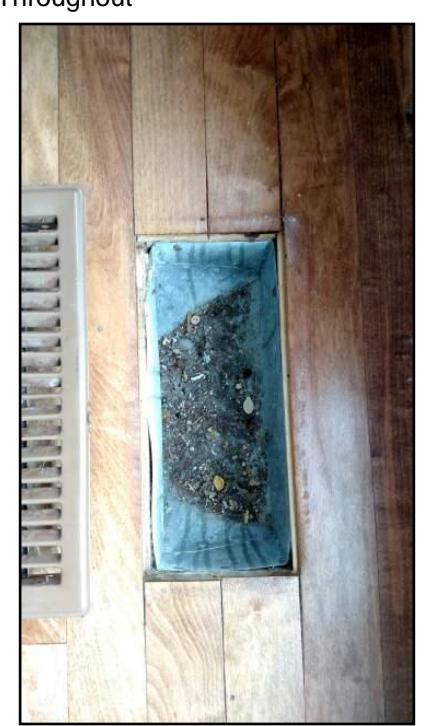
88. Dirty

22. Condition: • Dirty, obstructed or collapsed Inspector recommends cleaning. Implication(s): Increased heating costs | Reduced comfort Location: Throughout

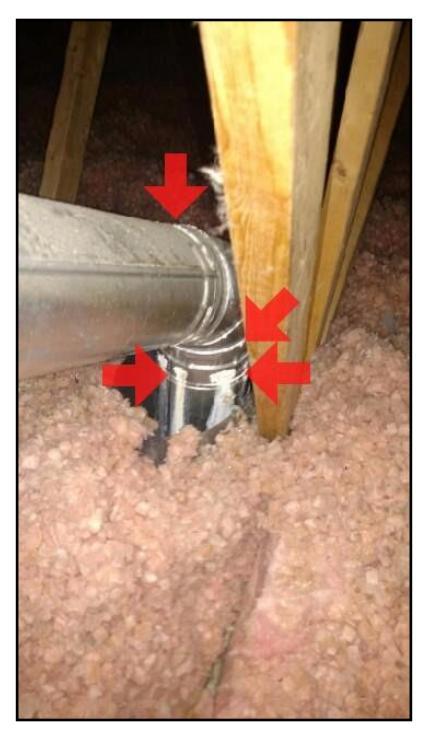
90. Zinc oxide

23. Condition: • White, powdery deposits(zinc oxide) on the exhaust flue indicated the presence of excessive amounts of moisture, typically related to condensation formed by improper furnace exhaust flue conditions. This condition may result in premature failure of furnace components. The Inspector recommends that the furnace be serviced by a qualified HVAC contractor.

Location: Attic

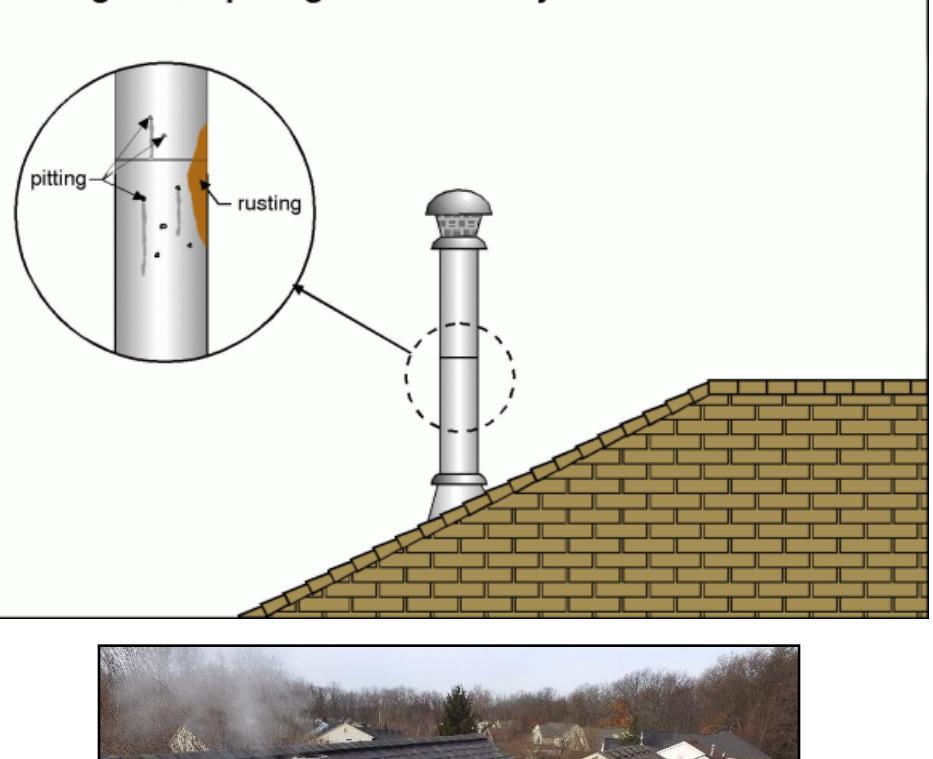
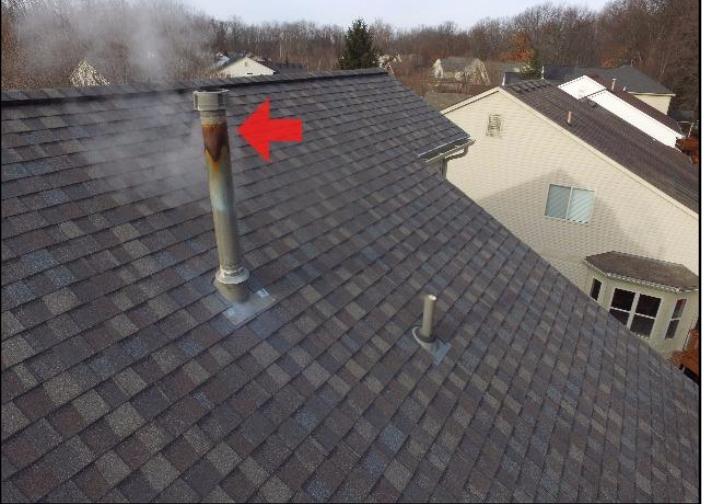
91. Chimney walls rusting or pitting

25. Condition: • Chimney walls rusting or pitting

Active leak and corrosion visible at the exhaust flue of the furnace in the attic indicated the presence of excessive amounts of moisture, typically related to condensation formed by improper furnace exhaust flue conditions. This condition may result in premature failure of furnace components. The Inspector recommends that the furnace be serviced and leak repaired by a qualified HVAC contractor.

Implication(s): Chance of movement | Hazardous combustion products entering home Location: Attic

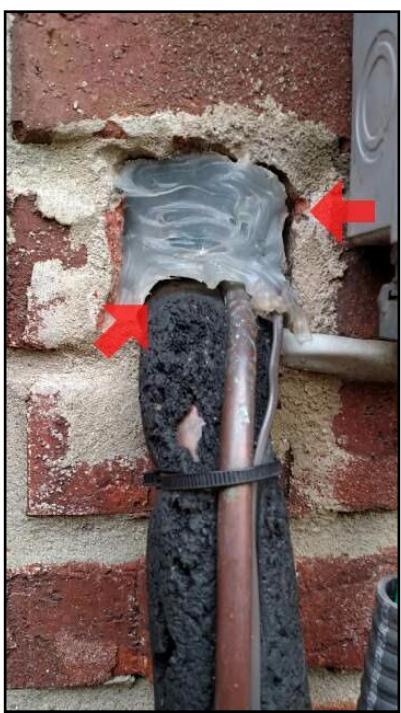
101.

The hole in the exterior wall-covering cut to allow penetration of air-conditioning lines should be sealed with an appropriate sealant to prevent moisture and insect entry.

Implication(s): Chance of water entering building | Chance of pests entering building **Location**: Left Side Exterior

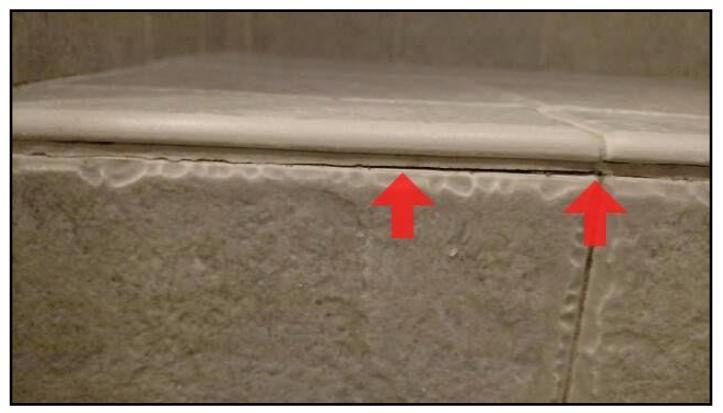
126. Grout loose, missing or deteriorated

Grout in the shower enclosure where the wall meets the floor/shower pan and the edge of the seat was deteriorated and may allow moisture intrusion of the wall/floor structure. The Inspector recommends that this sealant be repaired by a qualified licensed contractor.

Implication(s): Chance of water damage to contents, finishes and/or structure **Location**: Second Floor Master Bathroom

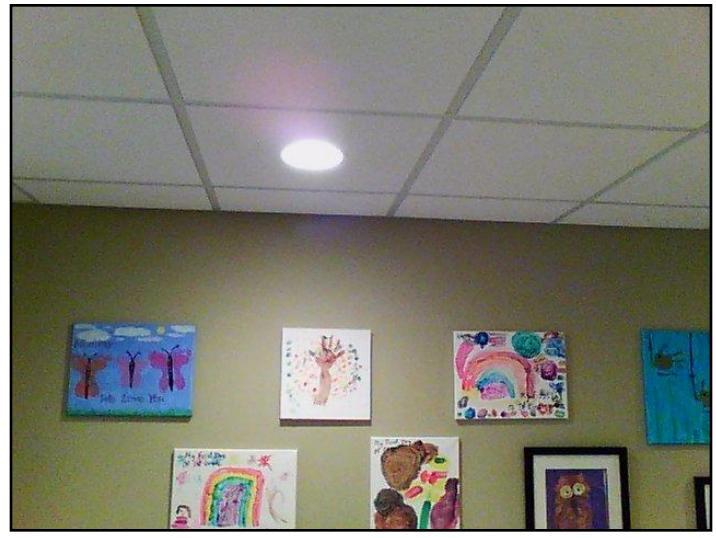
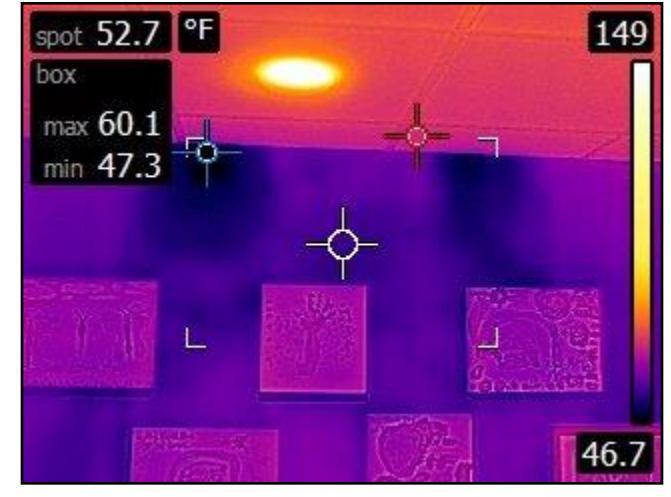
Thermal imaging indicated that insulation in the exterior walls has sagged, creating voids in the upper portions of wall cavities. These areas will experience greater heat movement through the walls than portions of the walls with intact insulation. This condition will increase heating and cooling costs.

Location: Basement

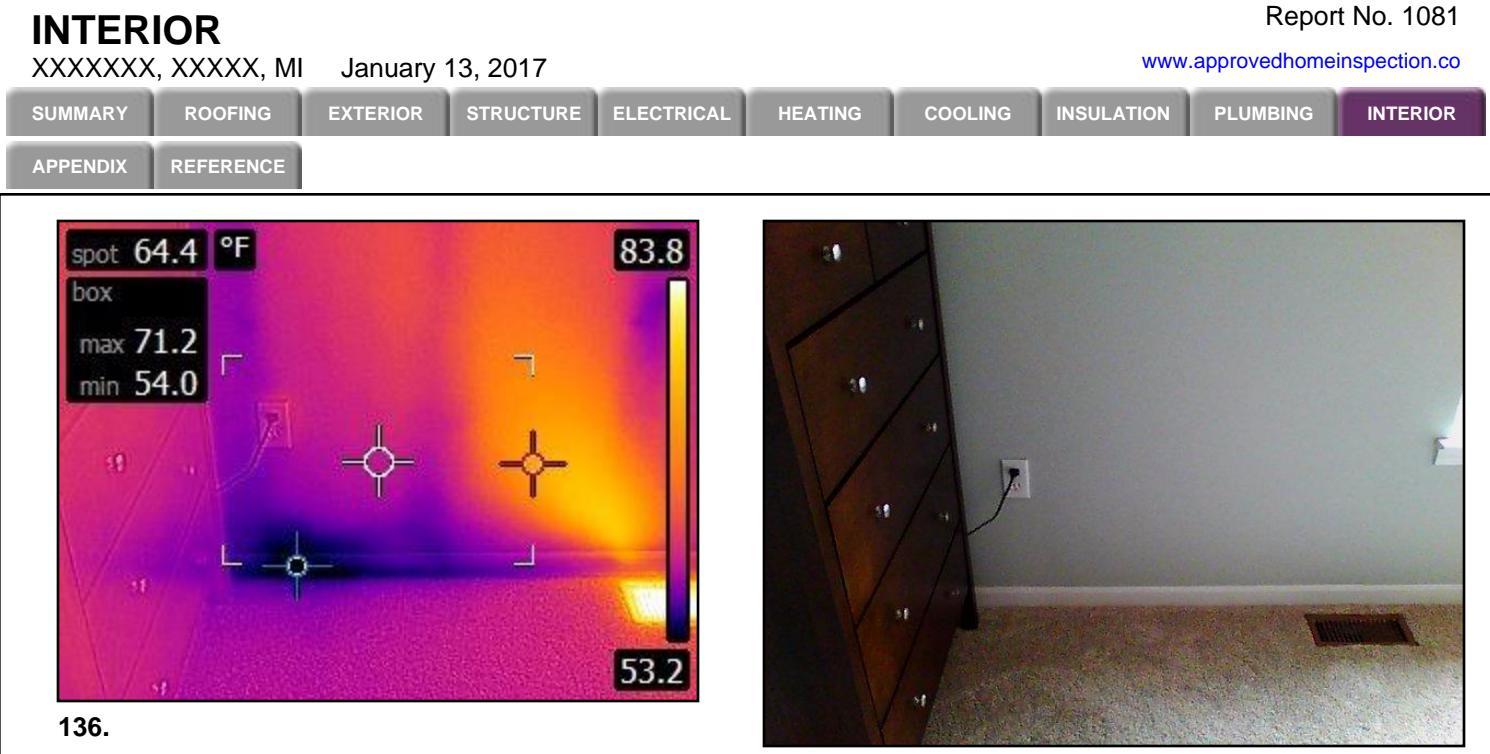
137.

36. Condition: • Voids in exterior walls

Thermal imaging indicated that insulation in the exterior walls has sagged, creating voids in the upper portions of wall cavities. These areas will experience greater heat movement through the walls than portions of the walls with intact insulation. This condition will increase heating and cooling costs.

Location: Master Bedroom

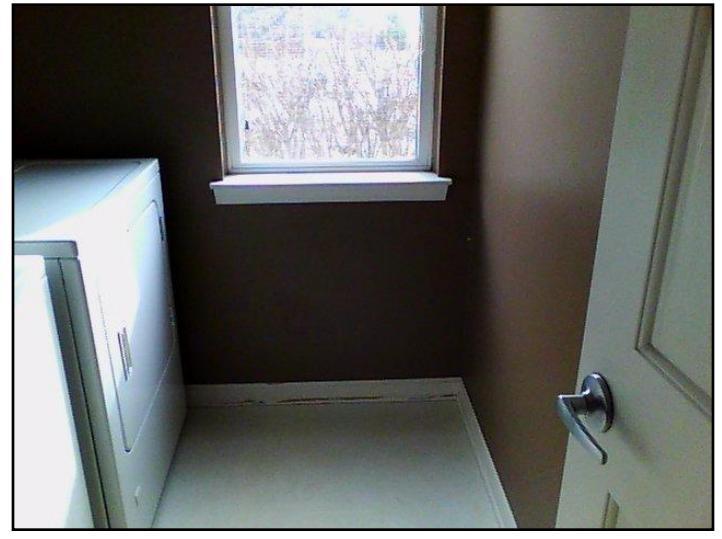
37. Condition: • Voids in exterior walls

Thermal imaging indicated that insulation in the exterior walls has sagged, creating voids in the upper portions of wall cavities. These areas will experience greater heat movement through the walls than portions of the walls with intact insulation. This condition will increase heating and cooling costs. Location: Laundry Area

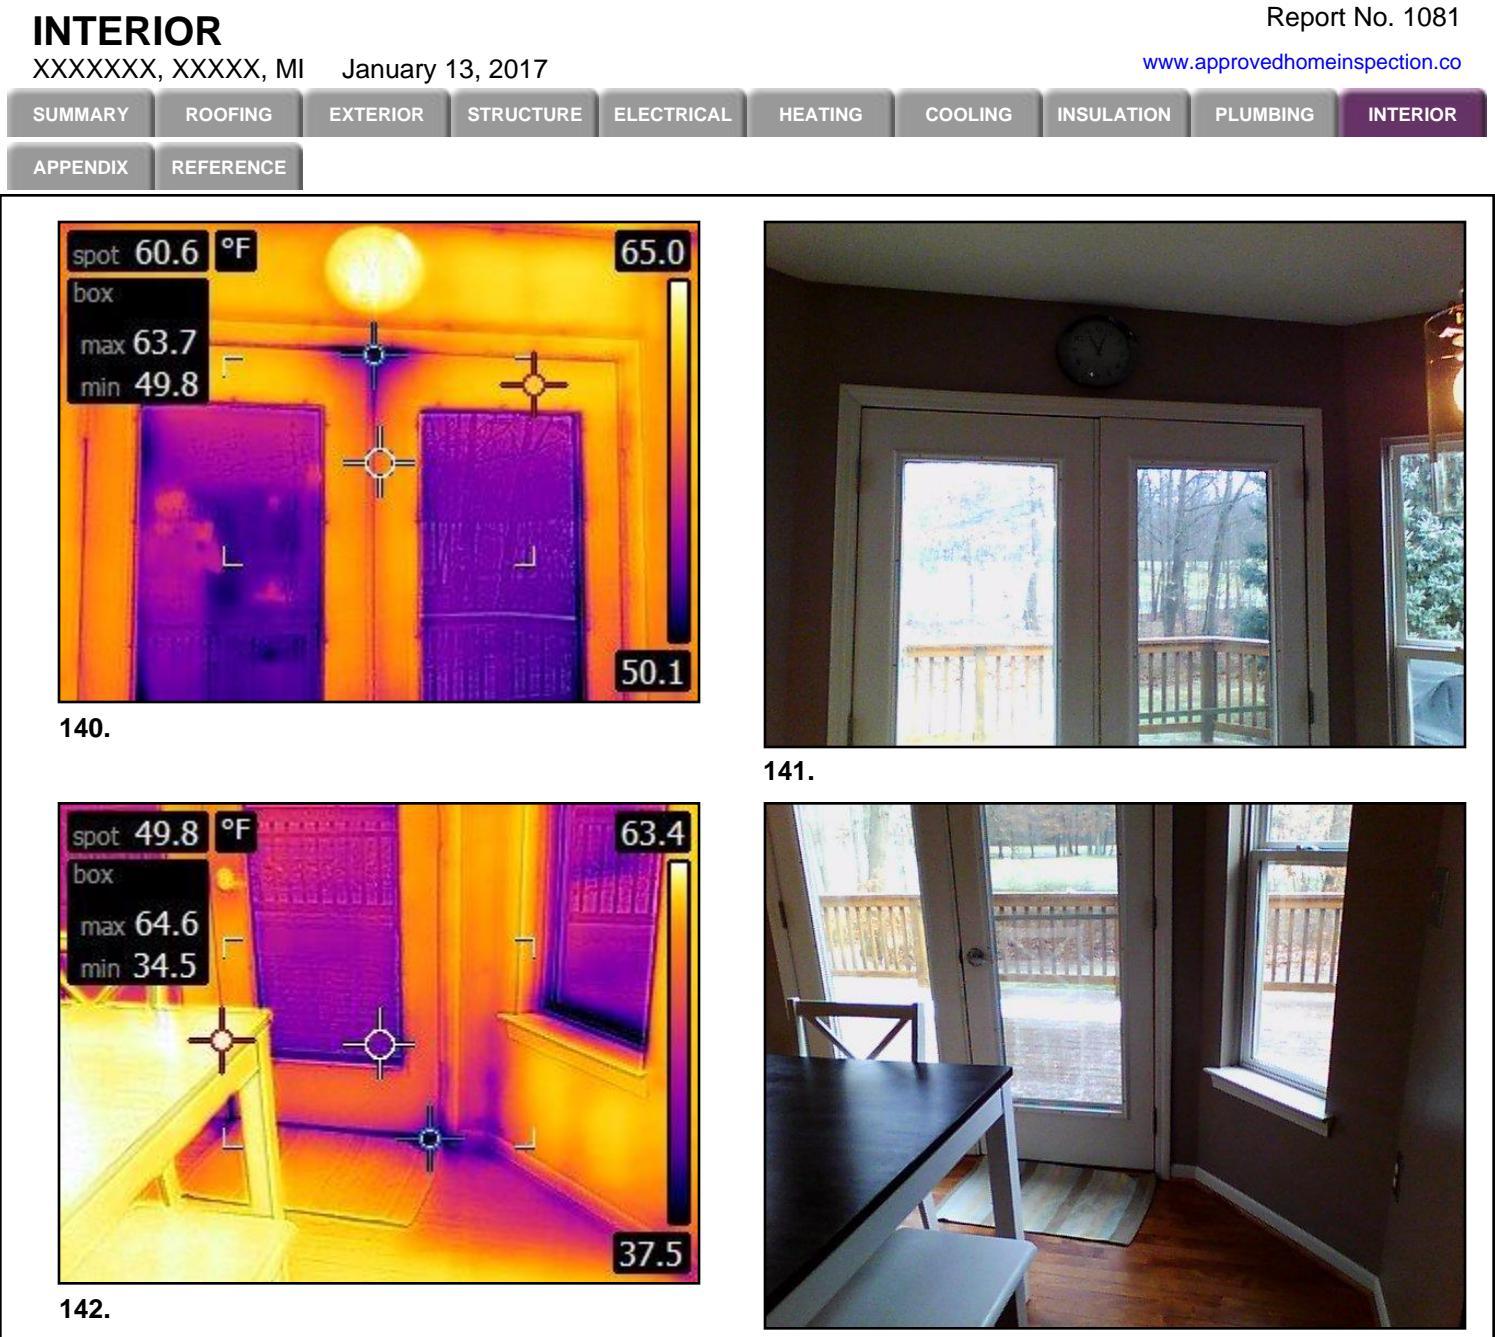
38. Condition: • Heat movement around doors

Thermal imaging indicated significant heat movement around exterior doors, indicating that gaps between the door jambs and the framed openings were not well insulated at the time of original installation. Improved performance of the home thermal envelope would involve installation of thermal insulation at these gaps. Consider consulting with a qualified contractor to discuss options and costs for improvement. **Location**: Dinette

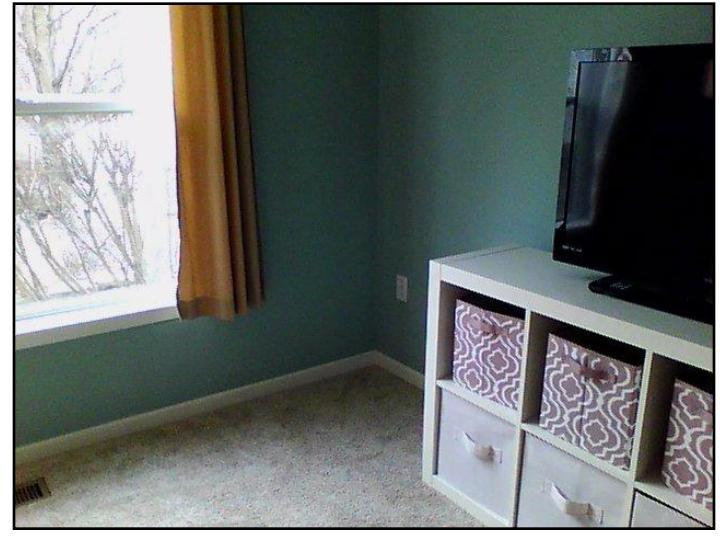
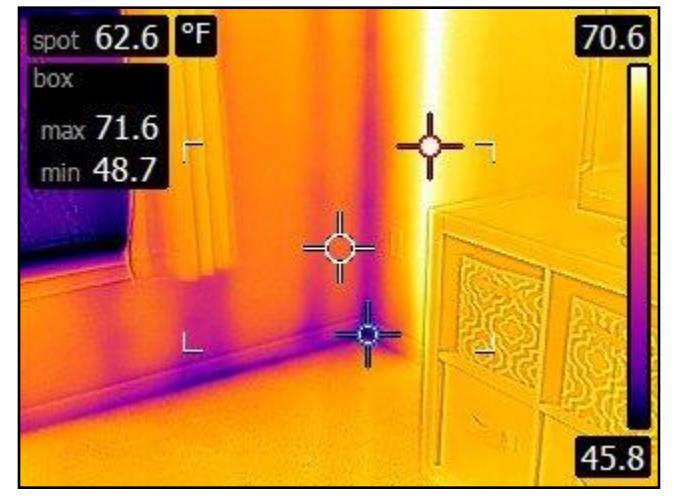
Thermal imaging indicated that insulation in the exterior walls has sagged, creating voids in the upper portions of wall cavities. These areas will experience greater heat movement through the walls than portions of the walls with intact insulation. This condition will increase heating and cooling costs.

Location: Office

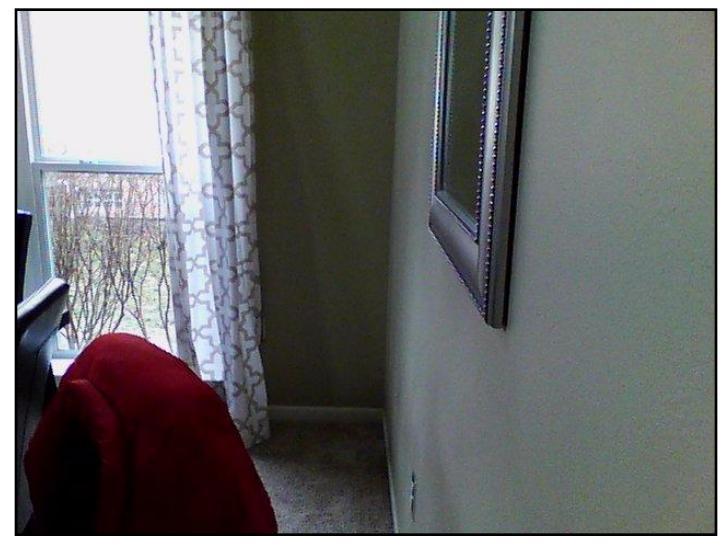
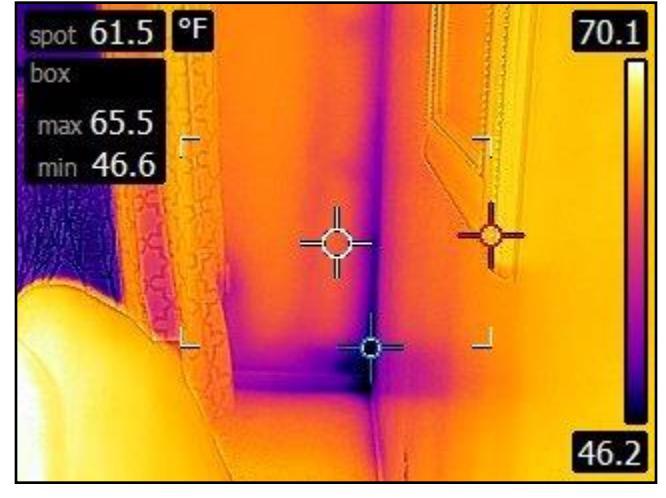
Thermal imaging indicated that insulation in the exterior walls has sagged, creating voids in the upper portions of wall cavities. These areas will experience greater heat movement through the walls than portions of the walls with intact insulation. This condition will increase heating and cooling costs.

Location: Living Room

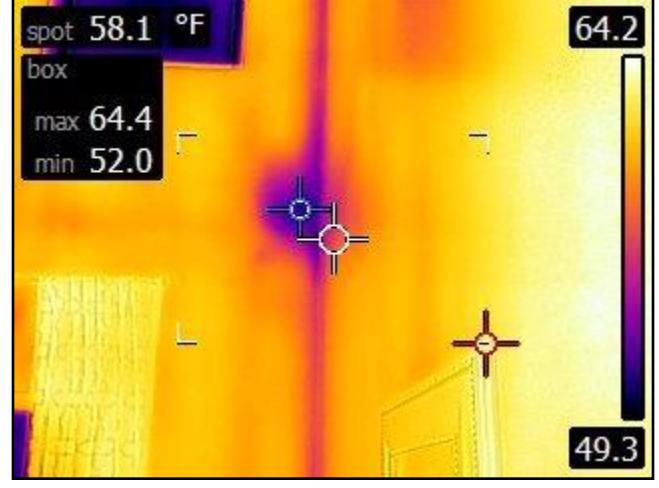
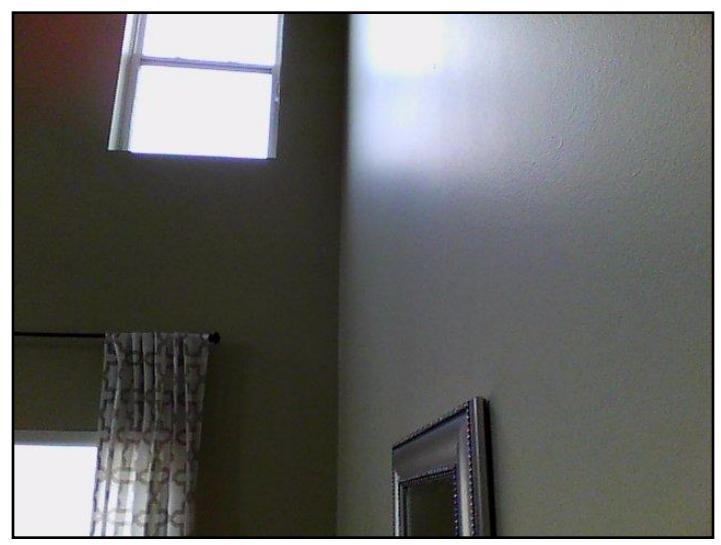
Thermal imaging indicated that insulation in the exterior walls has sagged, creating voids in the upper portions of wall cavities. These areas will experience greater heat movement through the walls than portions of the walls with intact insulation. This condition will increase heating and cooling costs.

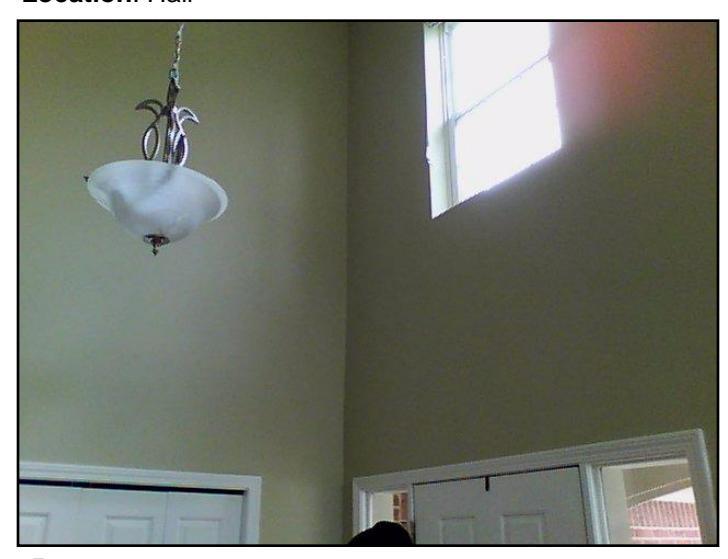
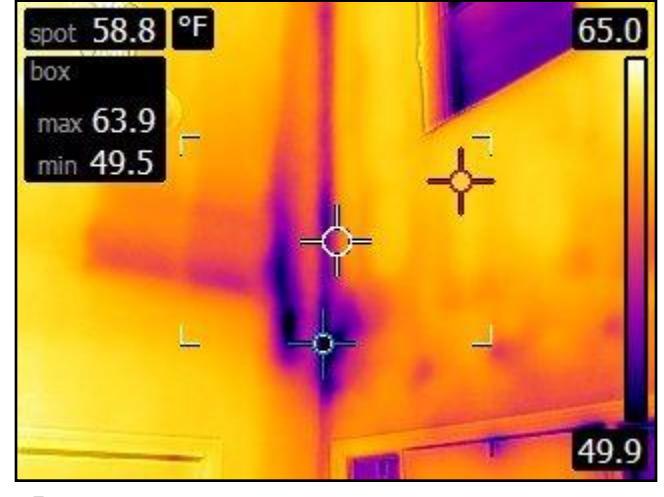
45. Condition: • Voids in exterior walls

Thermal imaging indicated that insulation in the exterior walls has sagged, creating voids in the upper portions of wall cavities. These areas will experience greater heat movement through the walls than portions of the walls with intact insulation. This condition will increase heating and cooling costs.

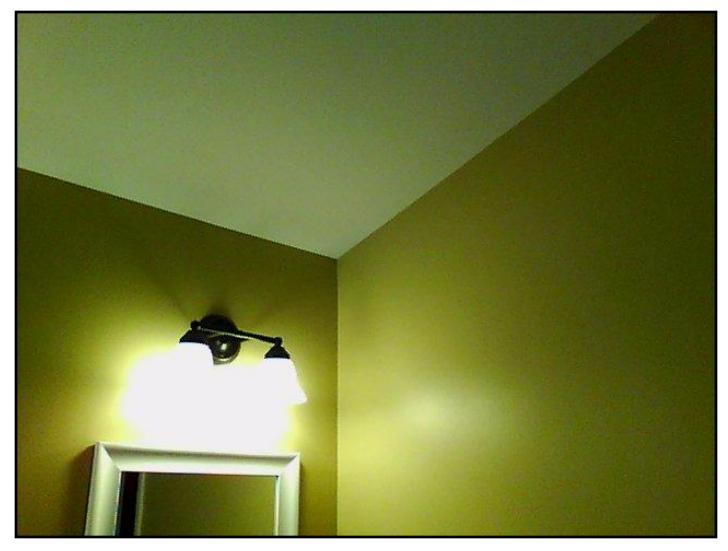
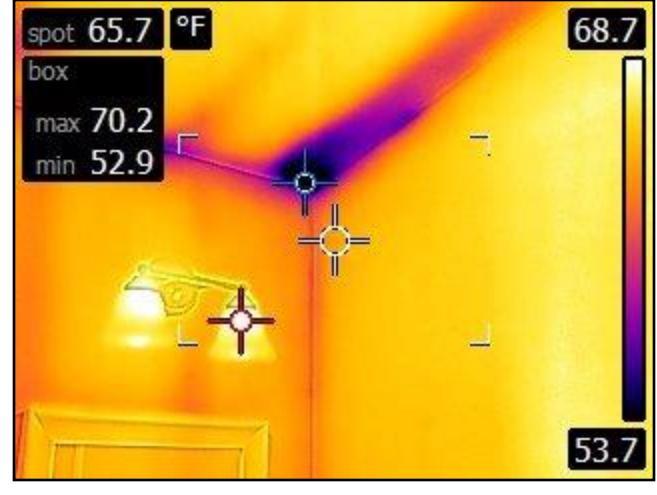
Thermal imaging indicated that ceiling insulation thickness is less near exterior walls. This is common in roof assemblies that have soffit and ridge vent systems designed to ventilate attic spaces and which require room for airflow above exterior walls. Lower insulation levels will result in greater heat loss through these areas, and a greater potential for the development of roof ice dams in climates with winter snowfall.

Location: Master Bathroom

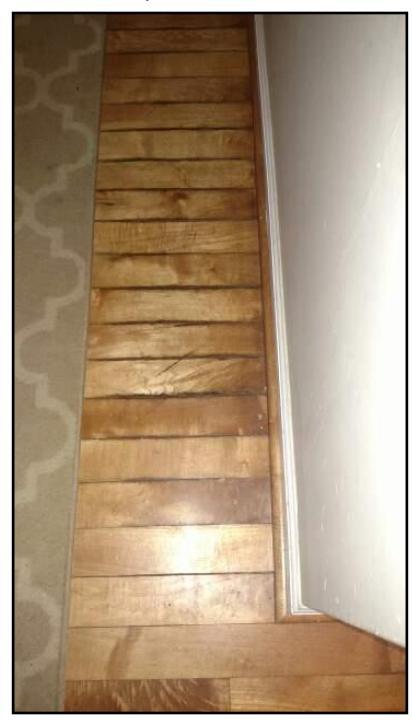
51. Condition: • Water damage to the wood floor in the hallway. The Inspector recommends that before the expiration of your Inspection Objection Deadline you consult with a qualified contractor to discuss options and costs for repair.

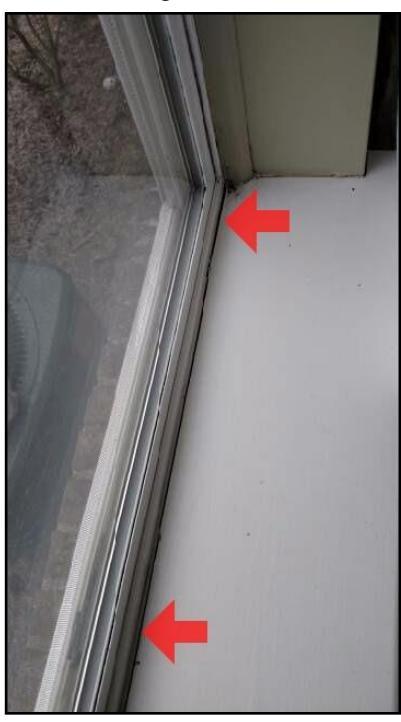
175. Living Room

54. Condition: • Caulking around the windows need to prevent moisture intrusion.

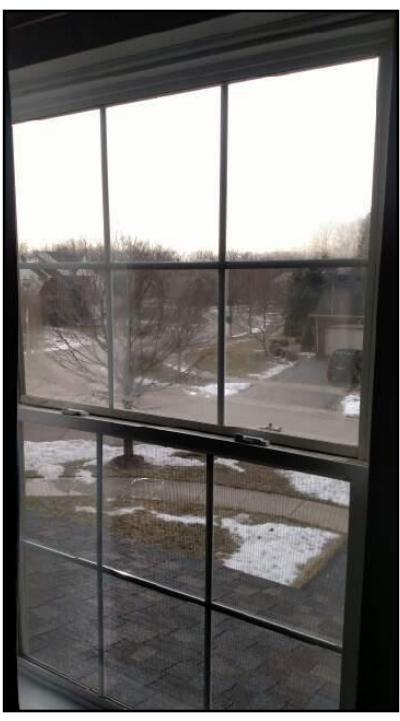
180. Lost seal on double or triple glazing

integrity. The Inspector recommends that before the expiration of your Inspection Objection Deadline you consult with a qualified contractor to discuss options and costs for repair or replacement. Replacement is more common. **Location**: Bedroom 1

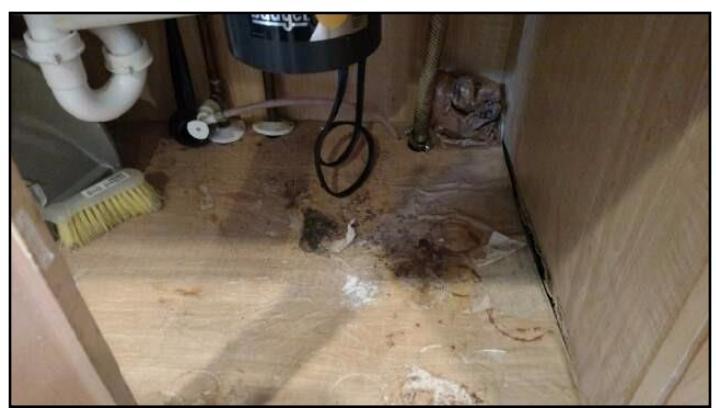
181. Water damage

Cabinet exhibited severe water damage. The Inspector recommends that before the expiration of your Inspection Objection Deadline you consult with a qualified contractor to discuss options and costs for repair or replacement. **Location**: Kitchen
