Your Inspection Report

XXXXXXX XXXXX, MI XXXX

INSPECTION DATE: Friday, January 13, 2017

| SUMM | ARY | | | | | | Report | t No. 1081 | |

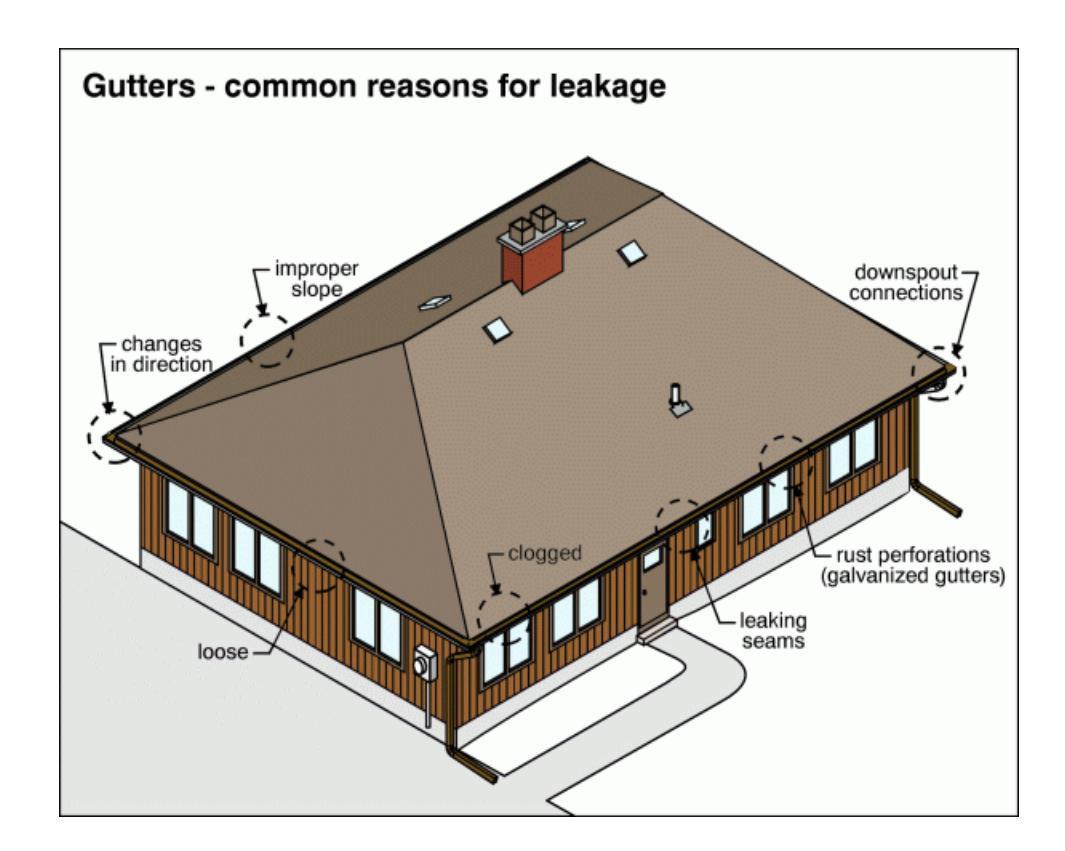
Debris visible in the gutters at the time of the inspection should be removed to encourage proper drainage. Implication(s): Chance of water damage to contents, finishes and/or structure Location: Throughout

Task: Clean

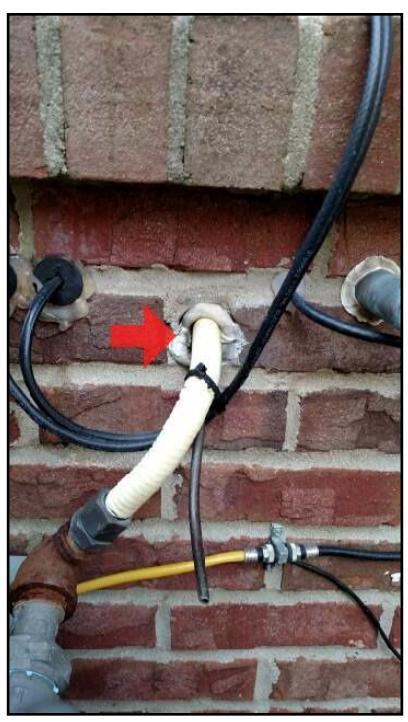
Location: Left Side

11. Left Side - Caulking needed

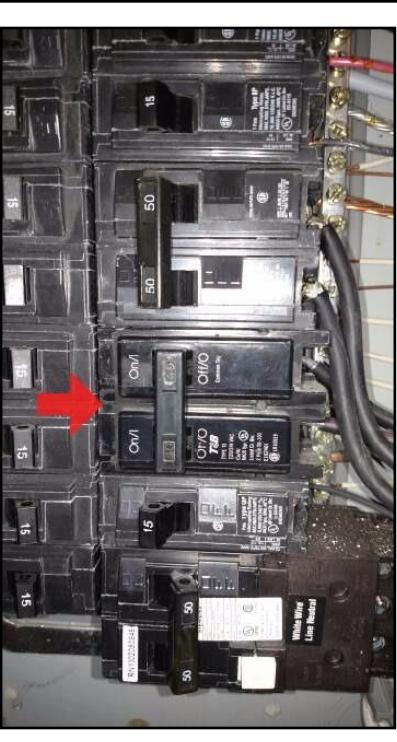
41. Wrong breaker for panel

Circuit breakers in the service panel were of a brand different from the main panel brand. Because circuit breakers made by different manufacturers vary in design, panel manufacturers typically require that breakers manufactured by their company be used in their panels. Breakers from one manufacturer used in the panel of another manufacturer may result in poor connections which can create a potential fire or shock/electrocution hazard. The Inspector recommends correction by a qualified electrical contractor.

Implication(s): Electric shock | Fire hazard

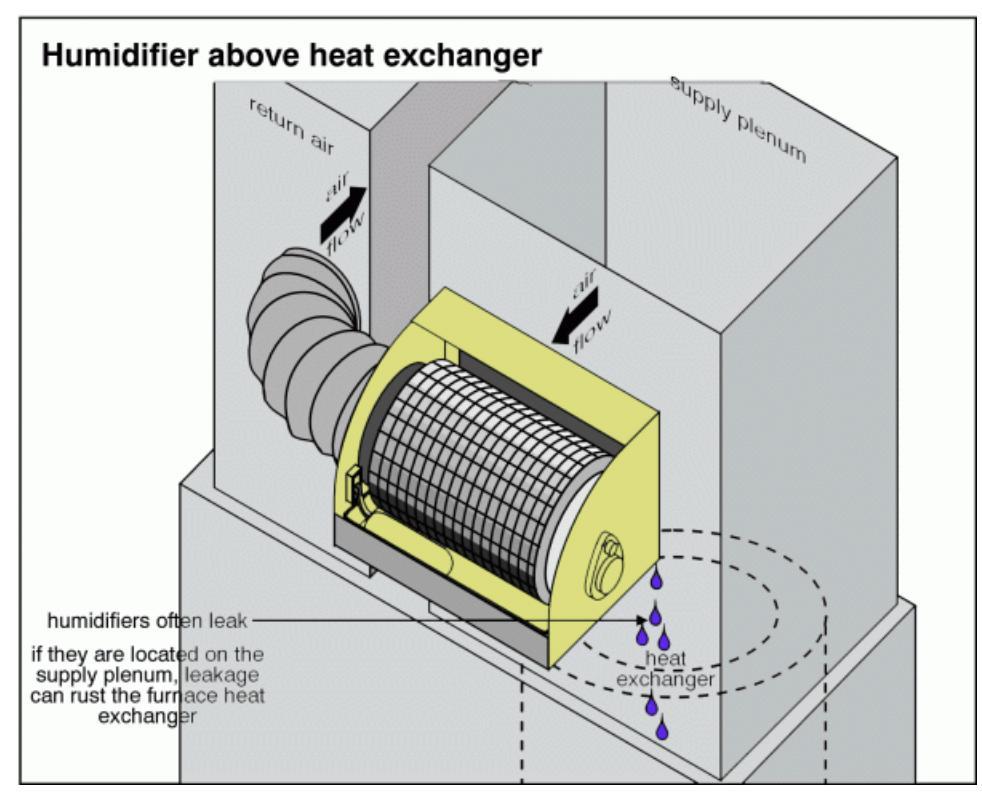
Water stains on the duct work indicate prior leak most likely do to a clogged pad. The Inspector recommends that the humidifier be serviced by a qualified HVAC contractor.

Implication(s): Chance of water damage to contents, finishes and/or structure | Damage to equipment **Location**: Basement

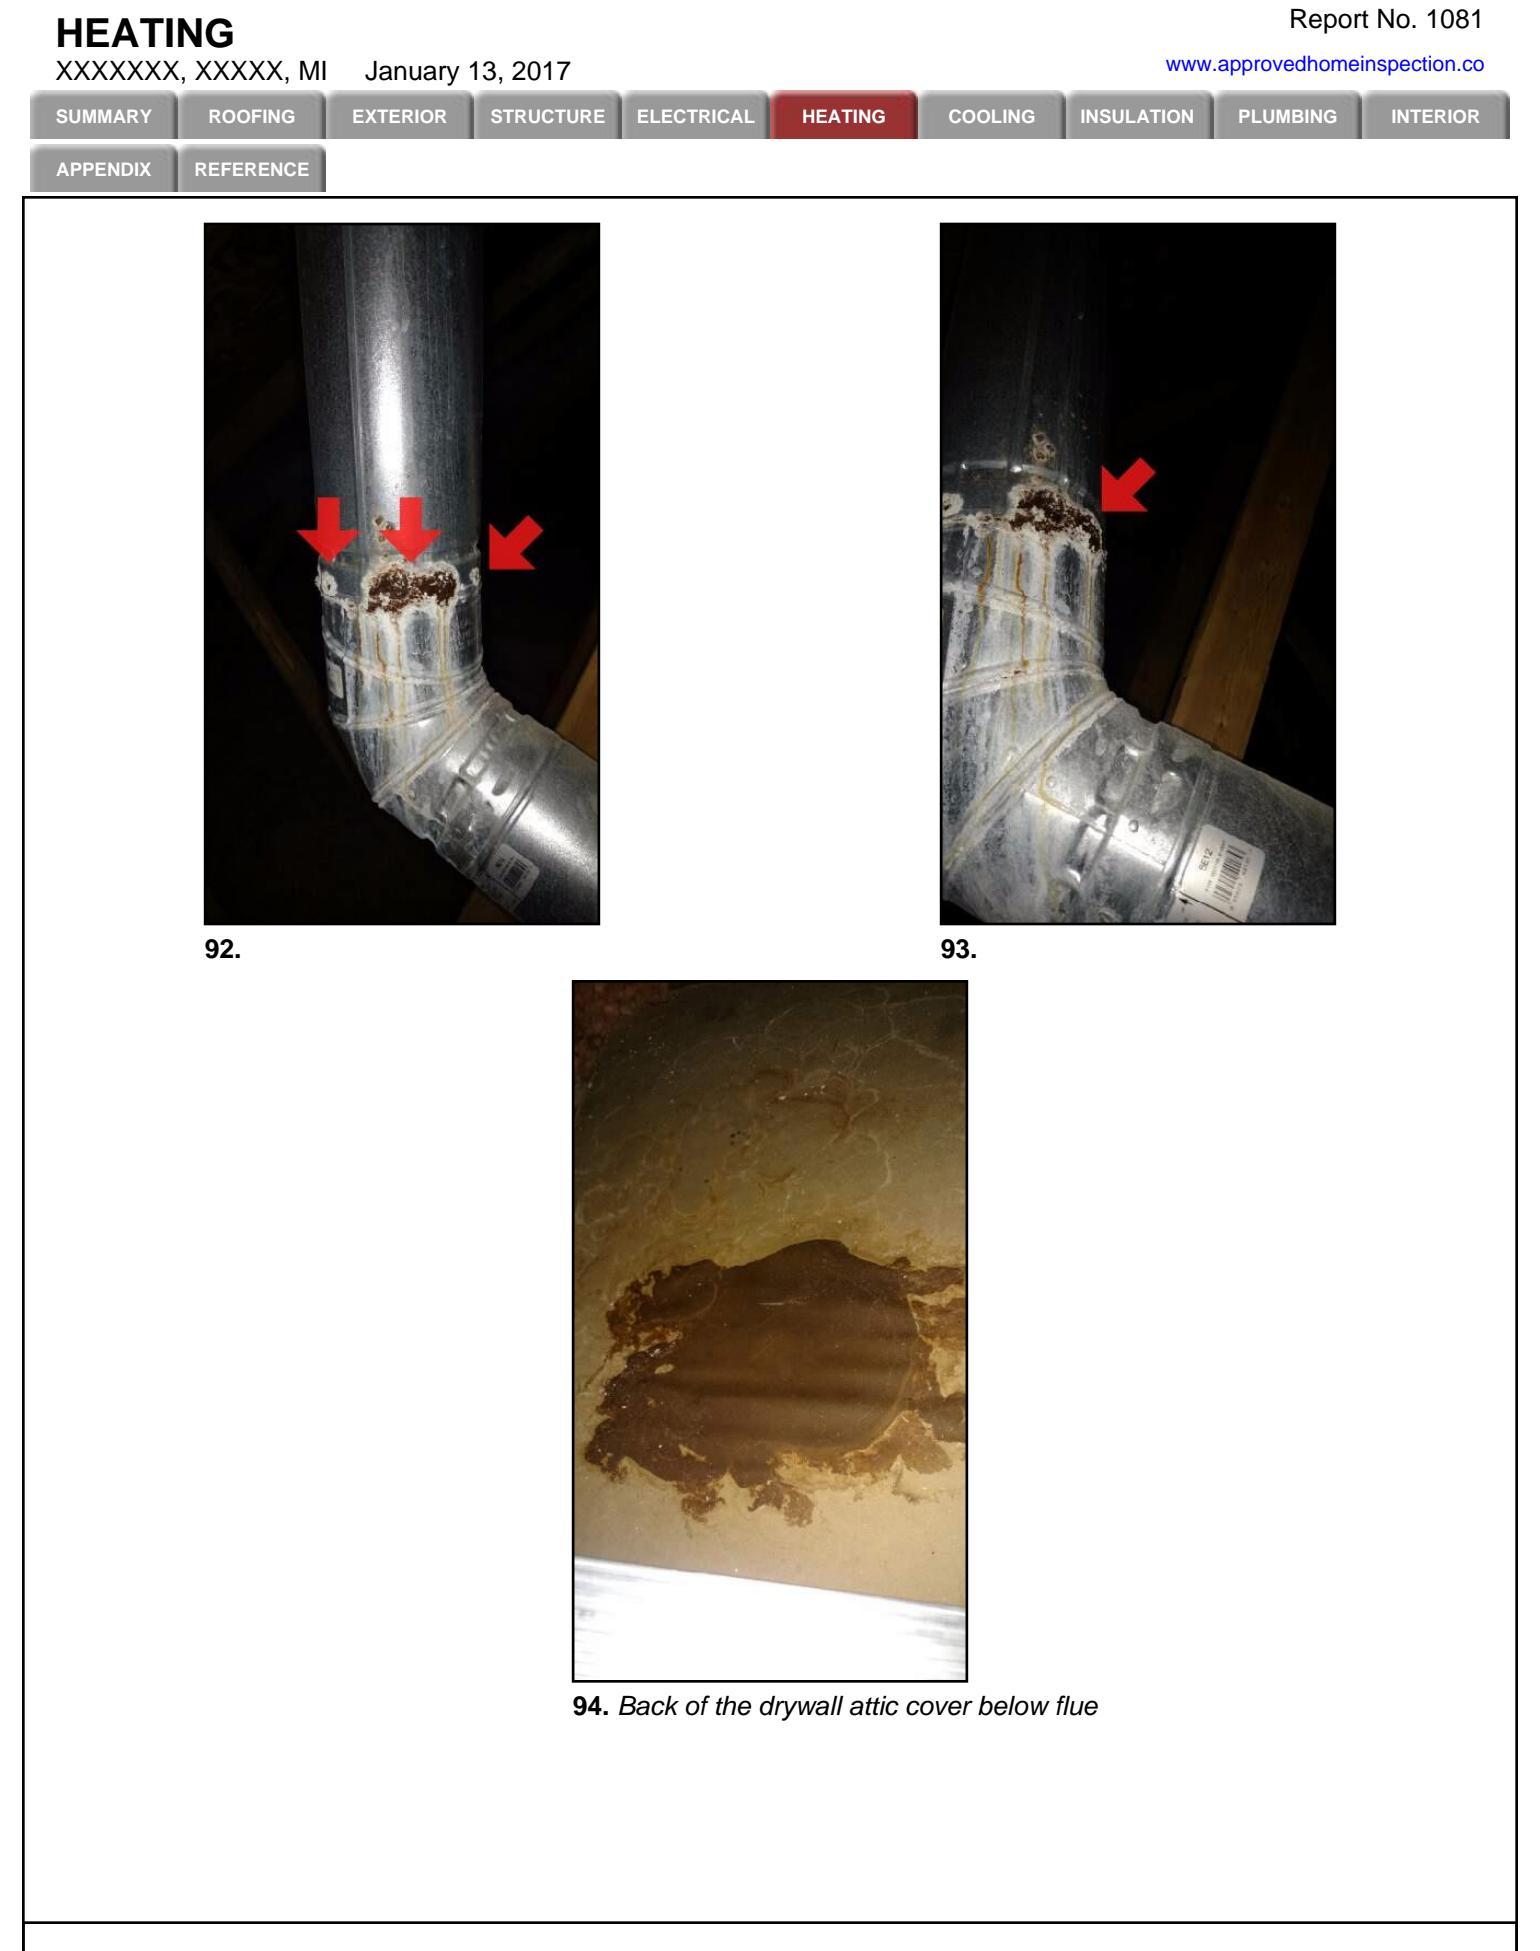
Active leak and corrosion visible at the exhaust flue of the furnace in the attic indicated the presence of excessive amounts of moisture, typically related to condensation formed by improper furnace exhaust flue conditions. This condition may result in premature failure of furnace components. The Inspector recommends that the furnace be serviced and leak repaired by a qualified HVAC contractor.

Implication(s): Chance of movement | Hazardous combustion products entering home Location: Attic

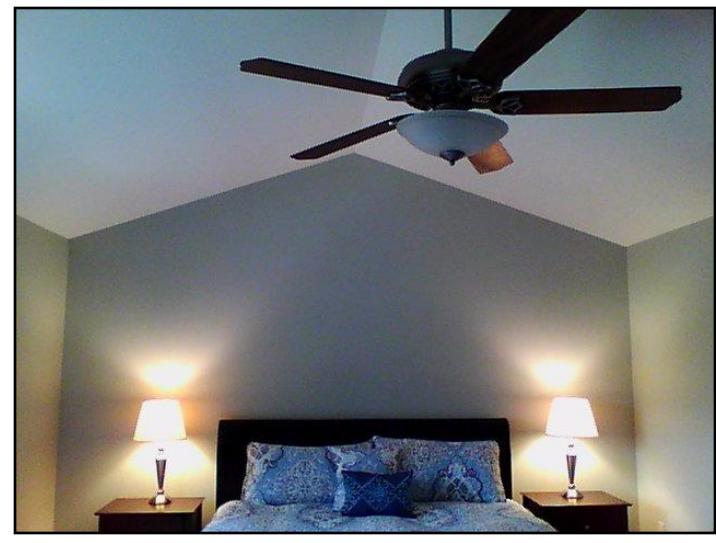
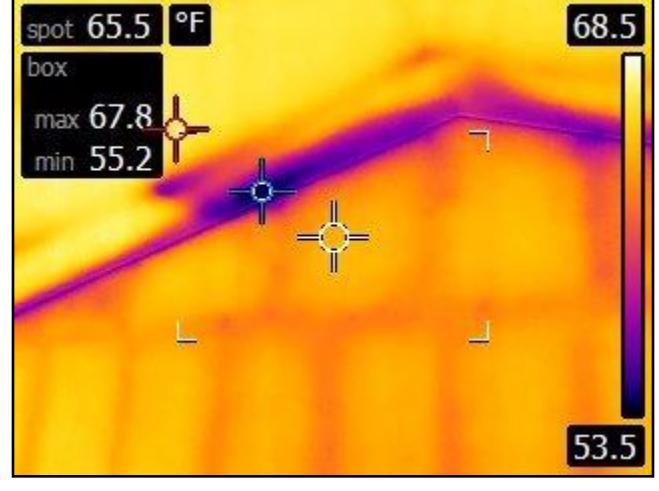
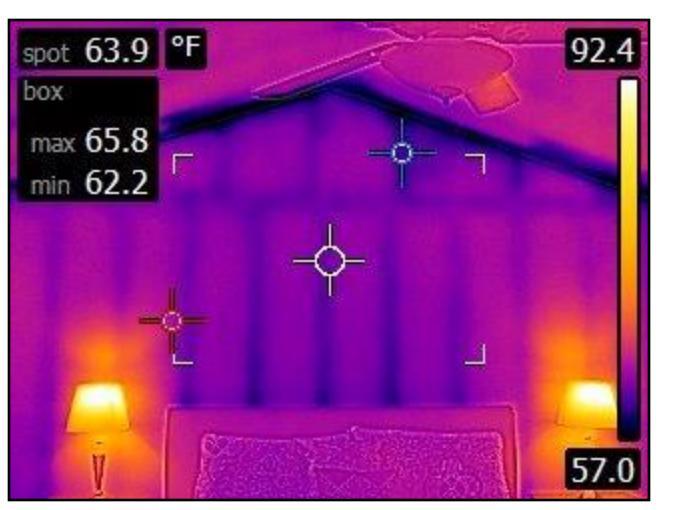
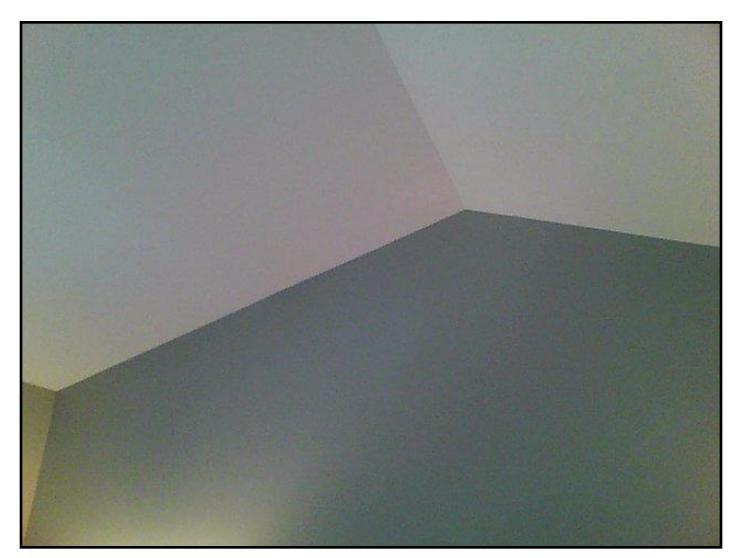
36. Condition: • Voids in exterior walls

Thermal imaging indicated that insulation in the exterior walls has sagged, creating voids in the upper portions of wall cavities. These areas will experience greater heat movement through the walls than portions of the walls with intact insulation. This condition will increase heating and cooling costs.

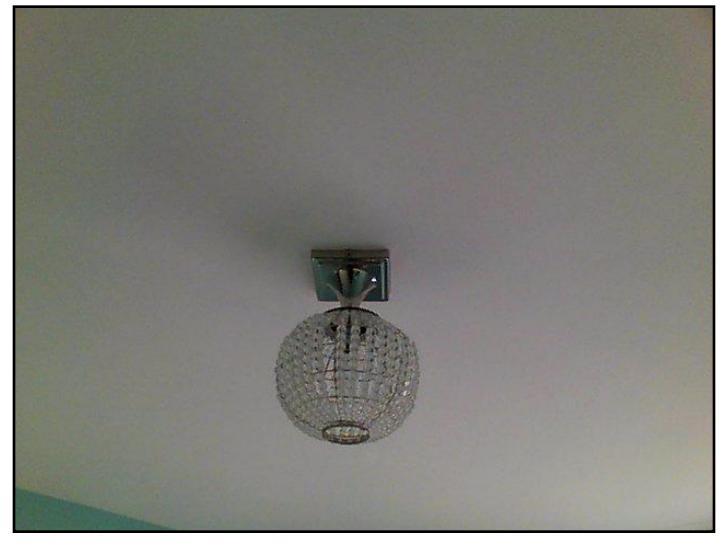
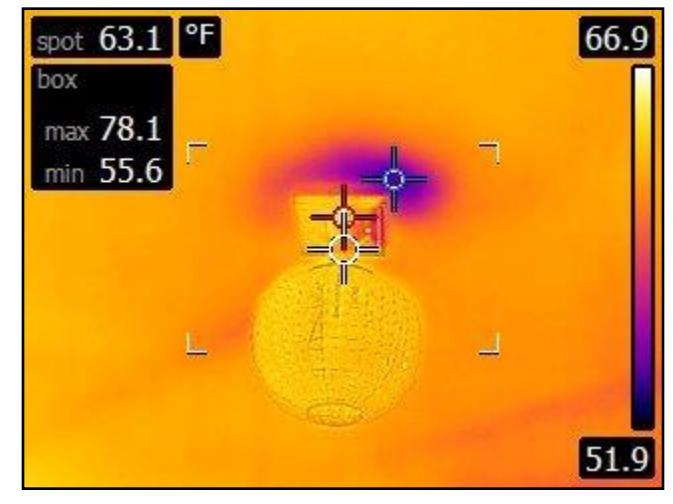
166.

49. Condition: • Ceiling voids

Thermal imaging indicated that insulation in areas of the attic was disturbed and does not provide full coverage. These areas will experience greater heat movement through the walls than portions of the walls with intact insulation. This condition will increase heating and cooling costs.

Location: Bedroom 2

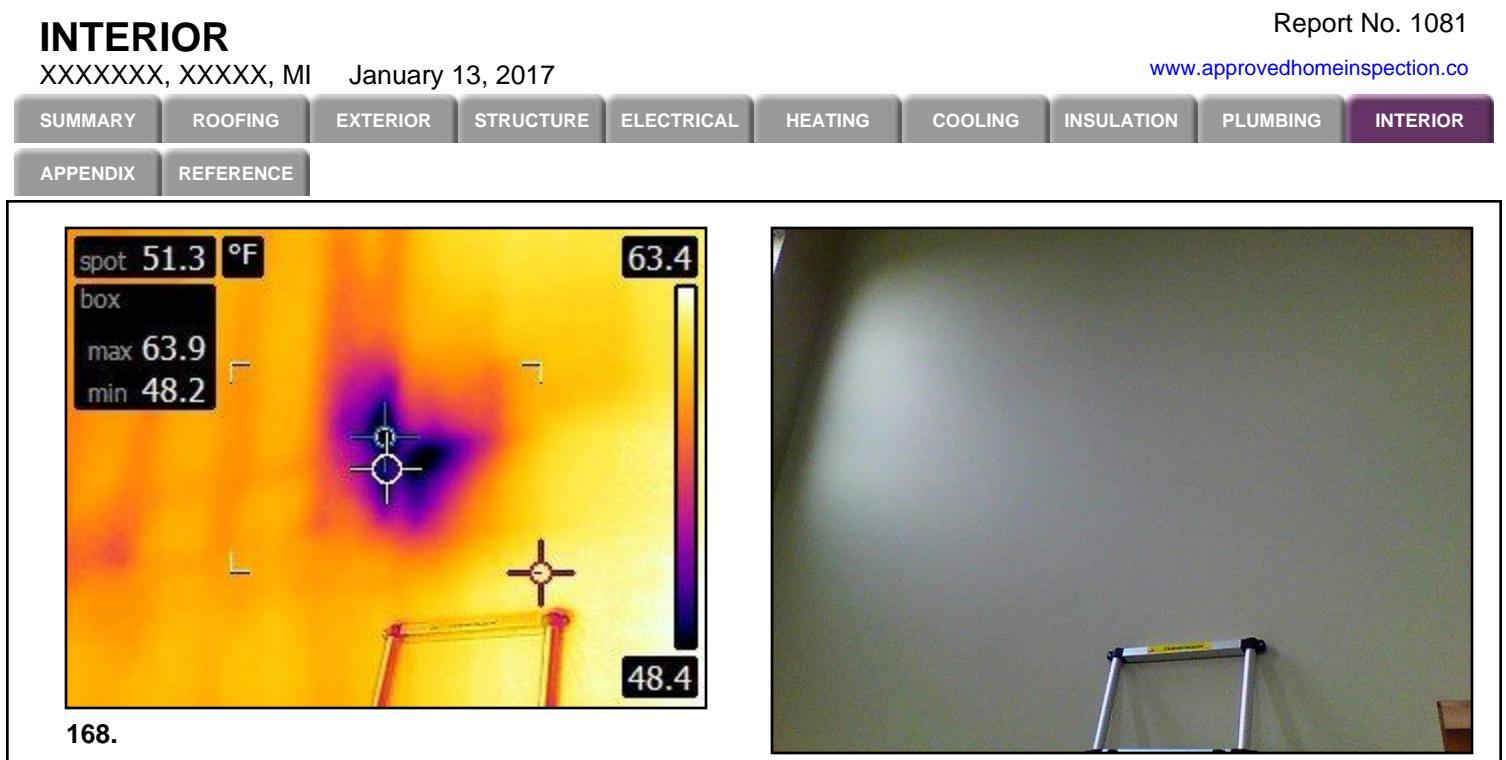
Thermal imaging indicated excessively high moisture levels in drywall materials in the living room. The area was directly below the master bathroom shower. (See Fixtures and faucets | Shower stall) The inspector recommends that before the expiration of your Inspection Objection Deadline an inspection be performed by a qualified contractor to identify and correct the source of moisture.

Location: Living Room

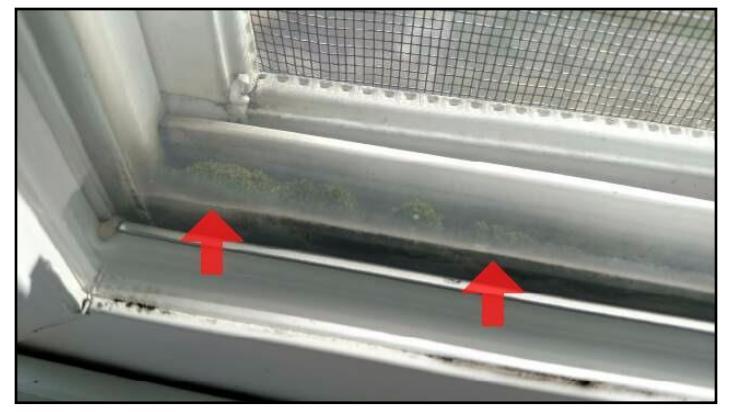
172. Bedroom 2

53. Condition: • Moss growth on the bottom track, condensation and stains visible on the glass of a double-pane window in Bedroom 2 and 3 indicated a loss of thermal integrity. The Inspector recommends that before the expiration of your Inspection Objection Deadline you consult with a qualified contractor to discuss options and costs for repair or replacement. Replacement is more common.

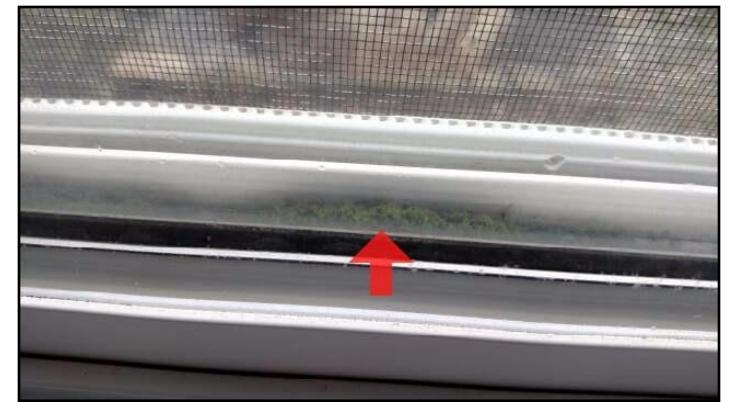
173. Bedroom 3

Location: Bedroom 3
